CALSPAN AIR BAG DEPLOYMENT INVESTIGATION

CALSPAN CASE NO. CA96-13

**VEHICLE #1 - 1996 SATURN SW2 WAGON
VEHICLE #2 - 1991 MITSUBISHI ECLIPSE**

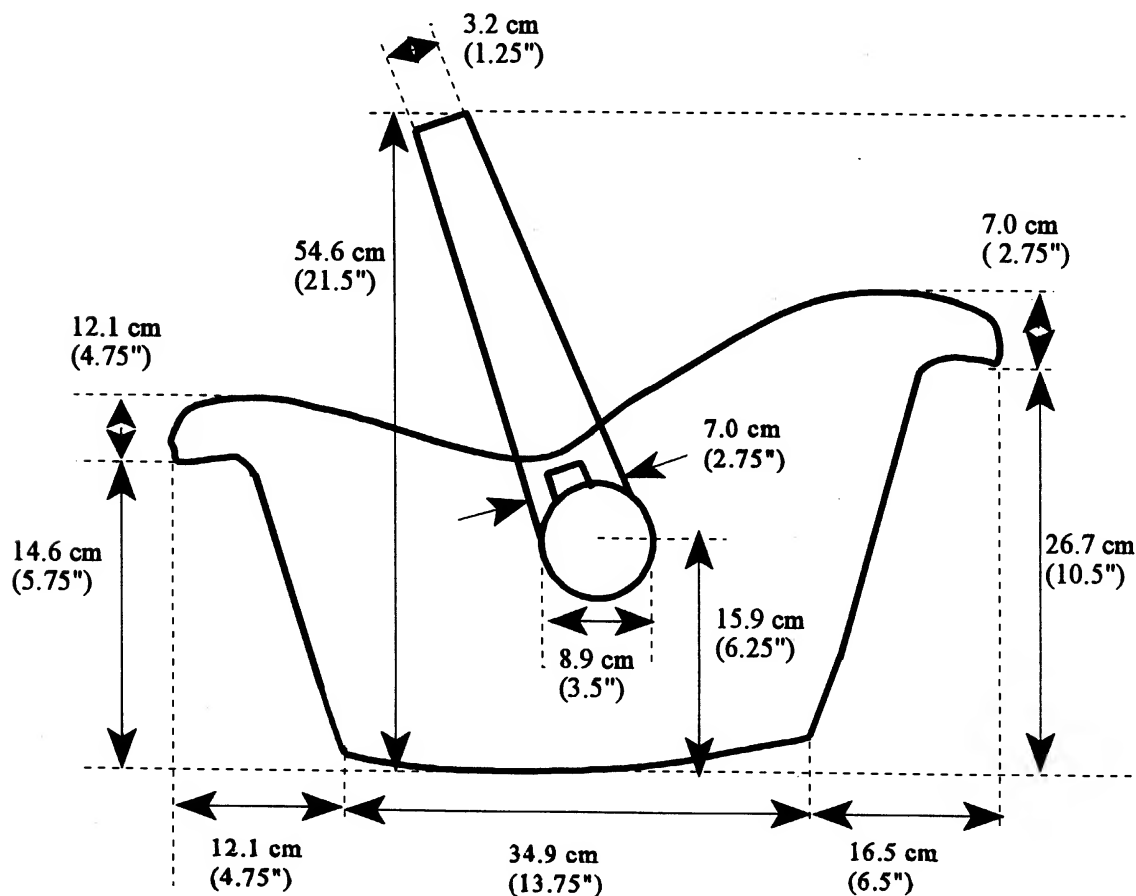
Infant Car Seat

The child safety seat was a **Infant Car Seat (rear-facing)** style which was secured in the right front passenger seat with the manual lap belt. The date of manufacture was **Measured dimensions are shown in the following illustration:**

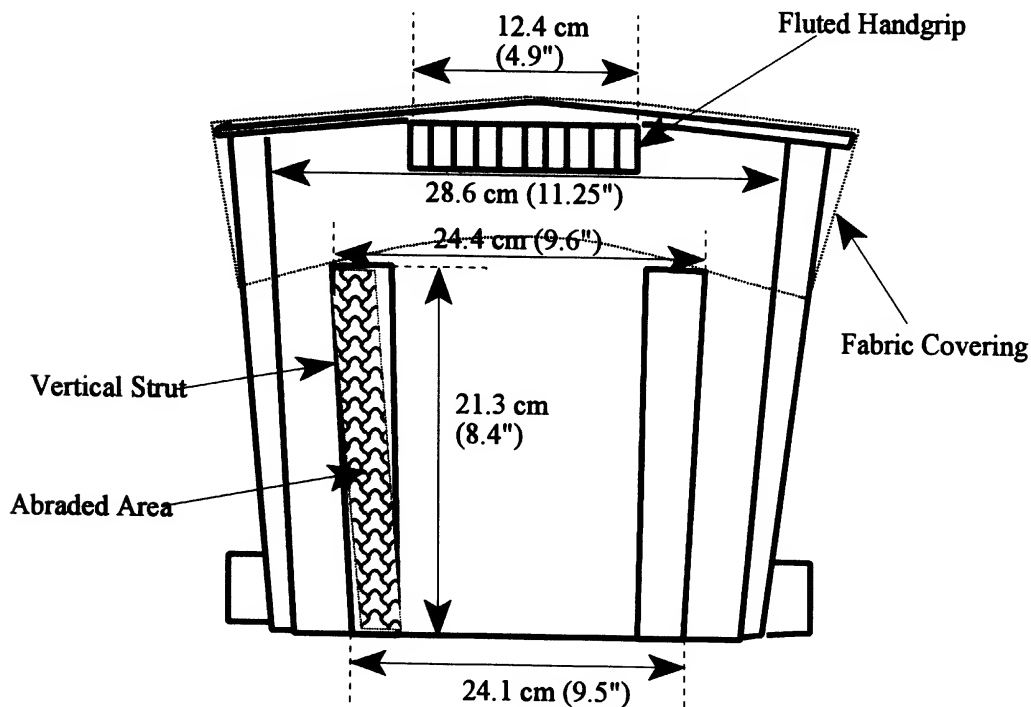
Outside Surface of the Child Safety Seat Back Support

The child safety seat covering was torn along both upper rear corners from contact by the passenger side air bag module cover during the deployment sequence. The tear on the left side was 6.4 cm (2.5") long and extended laterally from the left edge and 1.3 cm (0.25") below the top edge. The tear on the right side measured 5.1 cm (2.0") long extending laterally from the right edge and 1.3 cm (0.25") below the top edge.

The disk-like protrusions located on the rear surface of the upper handgrip of the child safety seat were contacted by the passenger side air bag module cover as the cover rotated upward during deployment. The handgrip area was 12.4 cm (4.9") wide and had eleven circular disks (refer to photograph #97 on page A-49) which were spaced 1.3 cm (0.5") apart. The left vertical strut of the rear surface of the child safety seat was abraded over the entire surface which was attributed to contact by the passenger side air bag during deployment.

The passenger side mid mount air bag module cover rotated upward as designed during the Supplemental Inflatable Restraint (SIR) actuation sequence and contacted the upper rear surface of the child safety seat's handgrip. This was evident from the vertical transfer/abrasion marks noted on the surface of the air bag module cover which were located along the lower edge of the cover. These transfer marks were consistent in size and shape to the design feature of the handgrip.

The passenger side air bag subsequently contacted the rear surface of the child safety seat back support resulting in an abraded area along the left vertical strut of the shell. The seat was propelled rearward in a head over heel rotational trajectory. During this air bag contact sequence, the child's head compressed the foam pad located under the seat covering and loaded the vinyl shell. As a result, he sustained a large subgaleal hematoma and effusion over the right scalp area, a depressed fracture of the right parietal-occipital region, and a contusion of the left fronto temporal area with a small subdural hematoma. The skull fracture and contusion of the right indicated the child's head was positioned slightly toward the driver at the time of the crash.

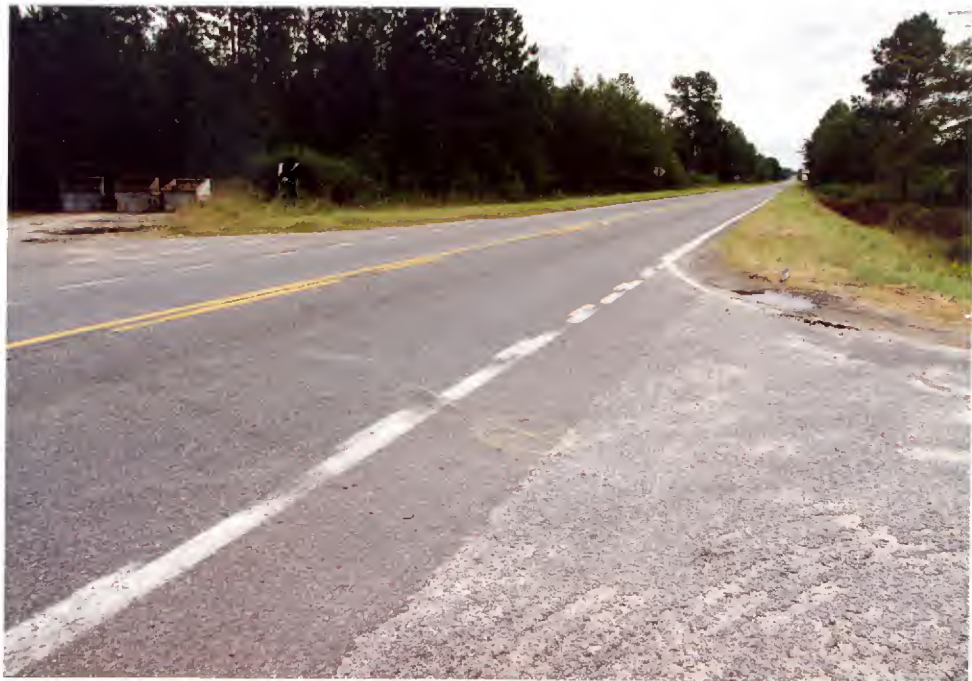
20. View of the POI.

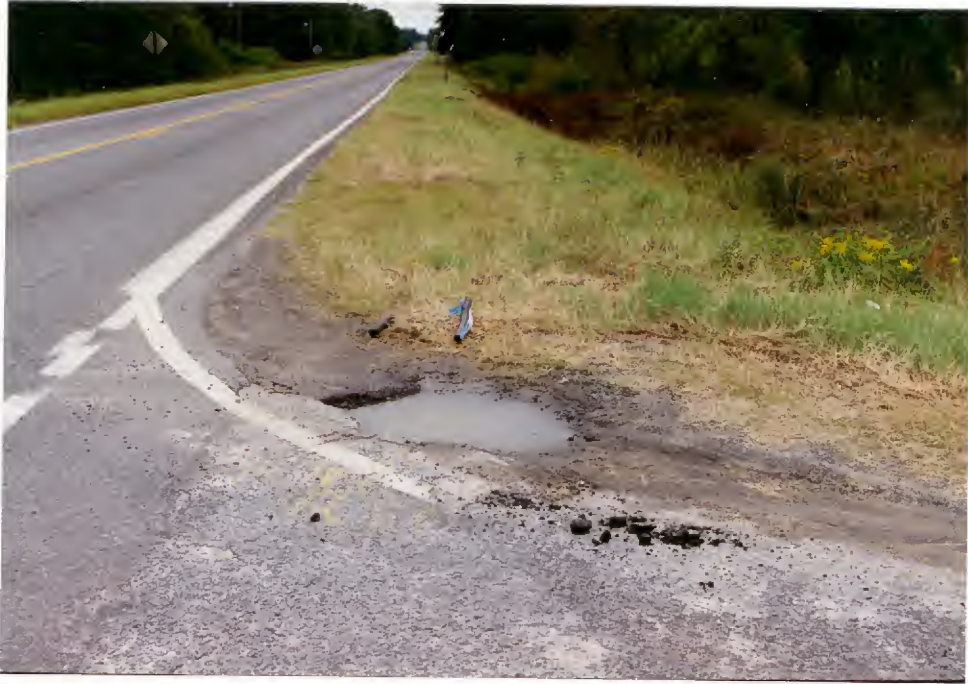
21. Vehicle #2's post impact, off roadway trajectory.

As Vehicle #1 initiated the left turn, Driver #2 attempted to avoid the crash by braking and steering to the right. Vehicle #2 departed the right side of the roadway and traveled across the northbound intersecting travel lane adjacent to the intersection boundary. Tire skid marks noted at the scene indicated Driver #1 observed the approach of Vehicle #2 and applied full brakes to avoid the crash (refer to photograph #8 on page A-4).

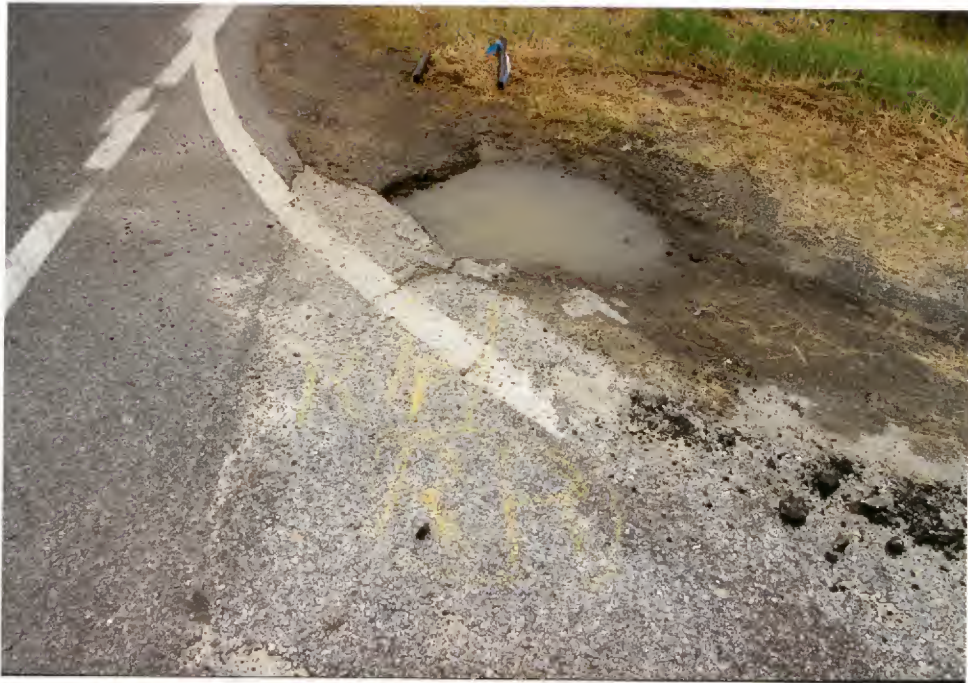
22. Close-up view of Vehicle #2's tire scuff marks on the south grass shoulder.

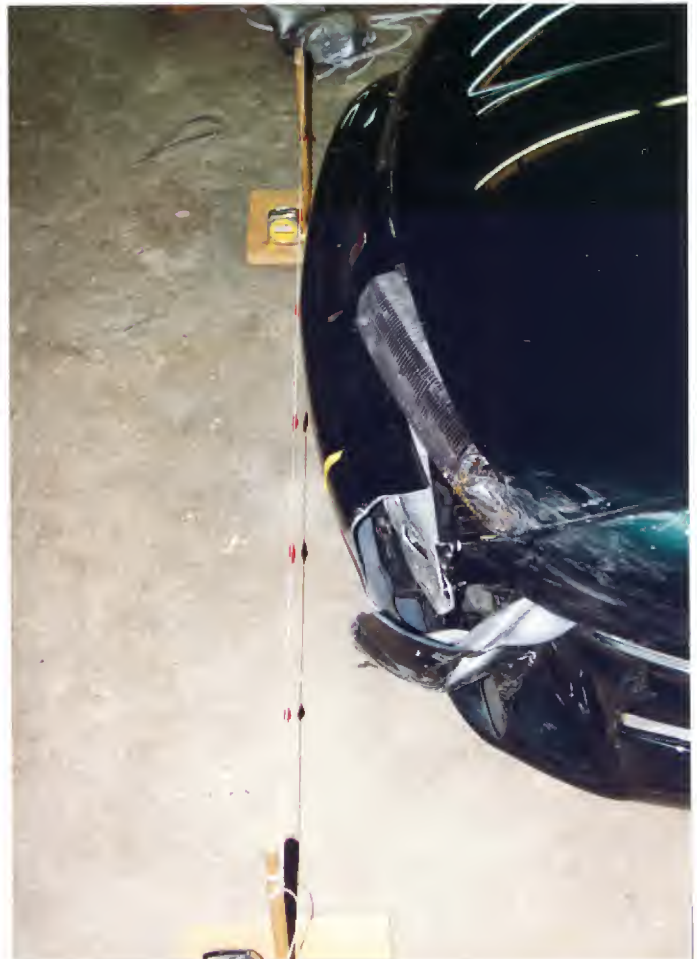
43. Lateral view of the left front fender of Vehicle #1.

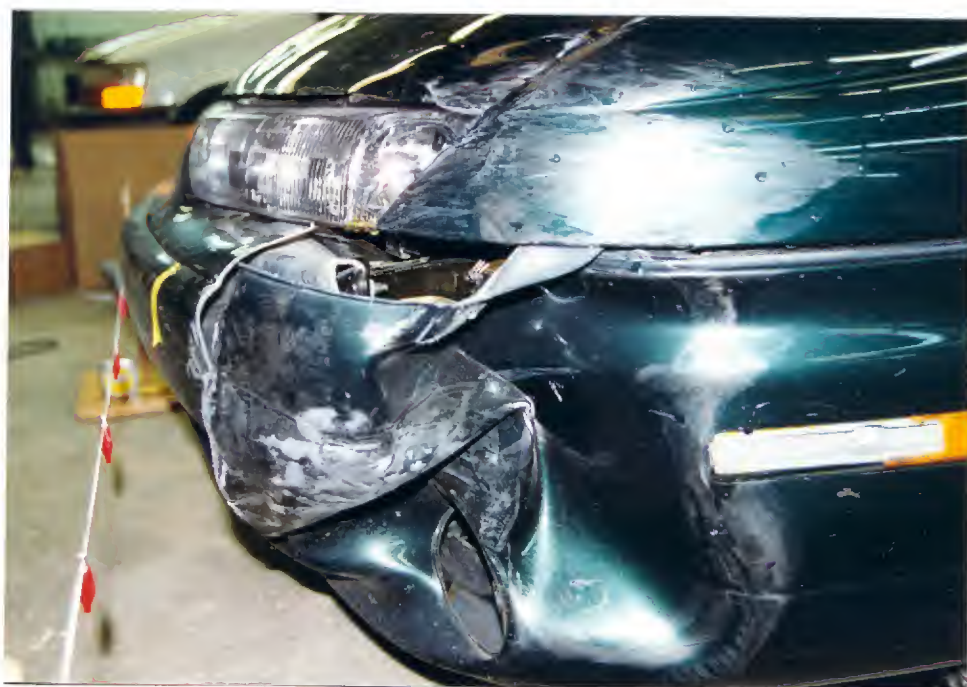
44. Close-up view of the left front corner.

Vehicle #1 sustained direct contact damage 30 cm (12") wide on the left front bumper. The maximum rearward displacement of the front bumper was 9.1 cm (3.6") located at the left front corner. The CDC for this impact was 01-FLEE-1.

The left front bumper of the 1996 Saturn Wagon (Vehicle #1) struck the left side plane of the 1991 Mitsubishi Eclipse (Vehicle #2). Vehicle #1 sustained direct contact damage to the front bumper starting 38.1 cm (15.0") left of the vehicle centerline and extending 30.5 cm (12.0") to the left corner of the bumper. The front bumper sustained a maximum rearward displacement of 9.1 cm (3.6"). Measured crush values along the front bumper are listed below:

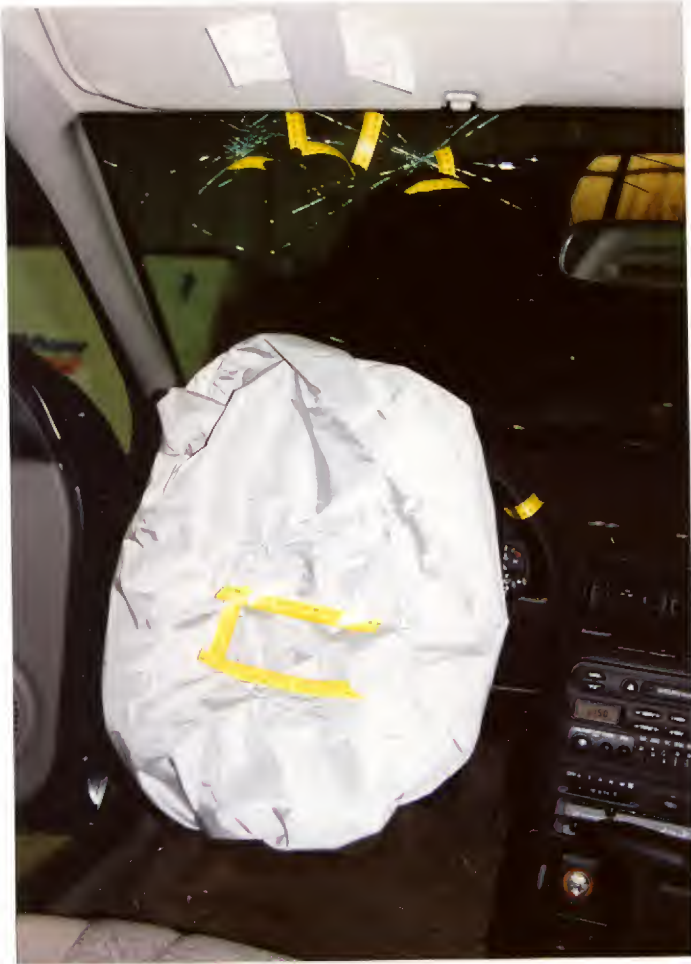
59. Vertical view of the driver side air bag, windshield, and sunvisor.

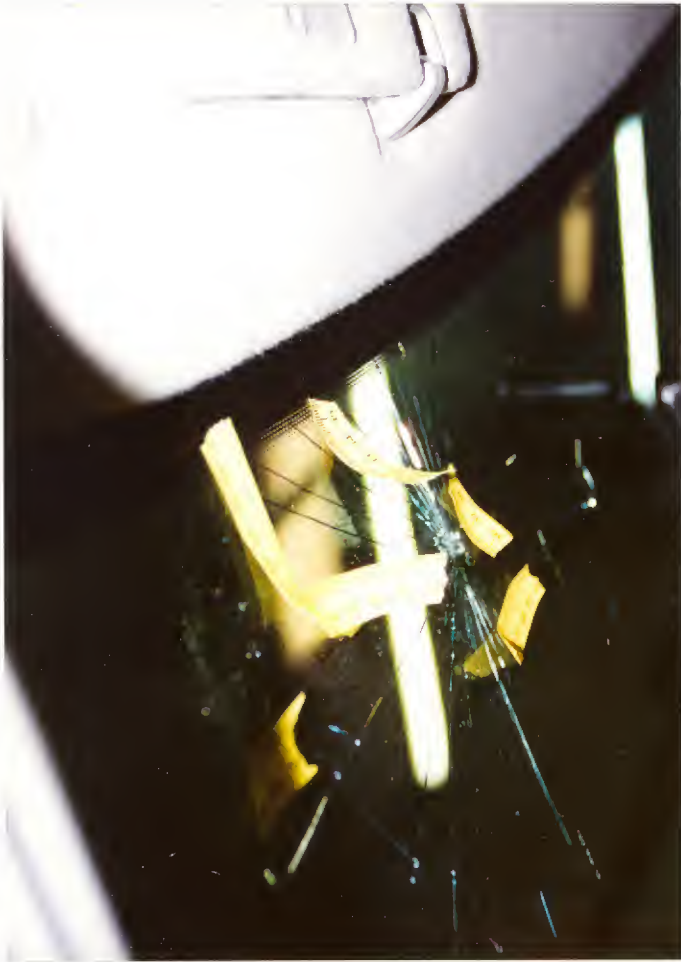
61. Close-up view of a small spider web glazing crack located at the upper left corner of the windshield.

The windshield exhibited two separate spider web type fractures which were attributed to driver contact. The first fracture was located 8.3 cm (3.25") below the windshield header and 43.8 cm (17.25") left of the vehicle centerline. A light smudge mark over the fracture site was attributed to contact by the driver's left hand. The second was located 27.9 cm (11.0") left of the vehicle centerline and 8.9 cm (3.5") down from the windshield header. A light smudge mark was also noted in the vicinity of the fracture which was attributed to contact by the driver's right hand.

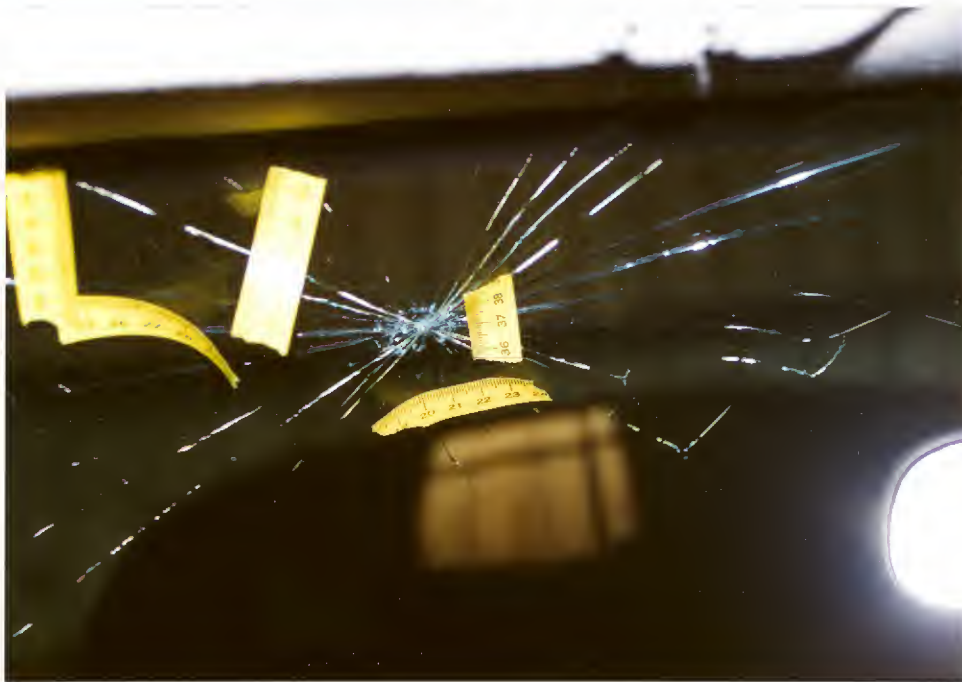
62. Close-up view of another glazing crack on the windshield located 15.9 cm (6.3") right of the crack shown in photograph #61.

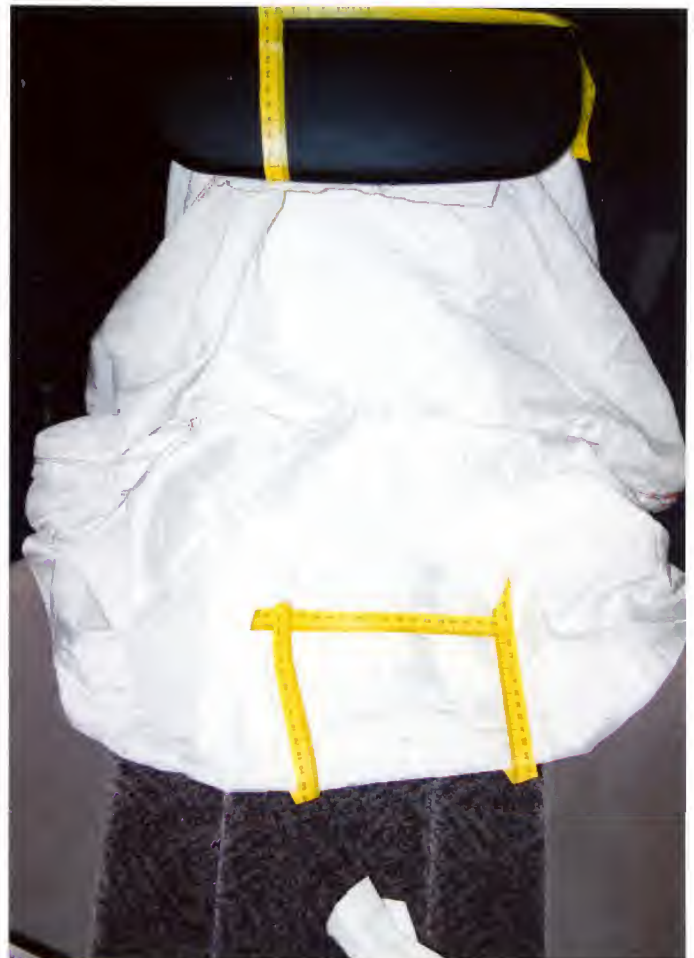
74. View of the passenger side air bag extended into the right front passenger seating area.

Several black smudge marks were noted on the center face of the passenger side air bag (refer to photograph #74, #75 on pages A-37, A-38). These marks were the result of loading on the underside of the air bag module cover during deployment. The marks were mainly confined to an area starting at the air bag center line and extending 10.2 cm (4.0") to the right. This area was located 74.0 cm (29.1") from the inflator unit.

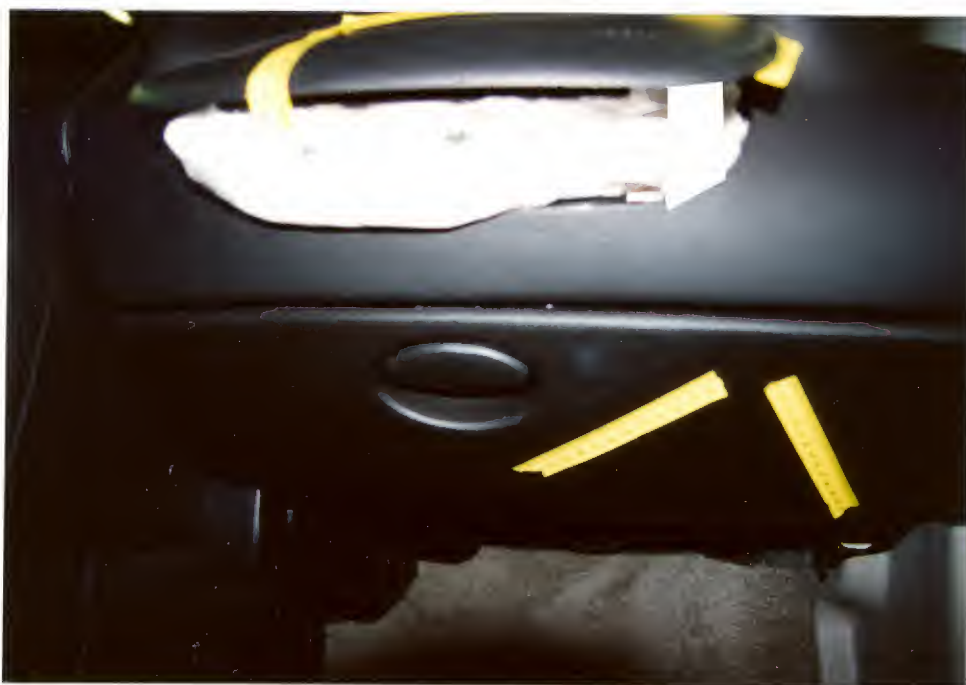
77. Close-up view of the glove compartment door showing several scuff marks.

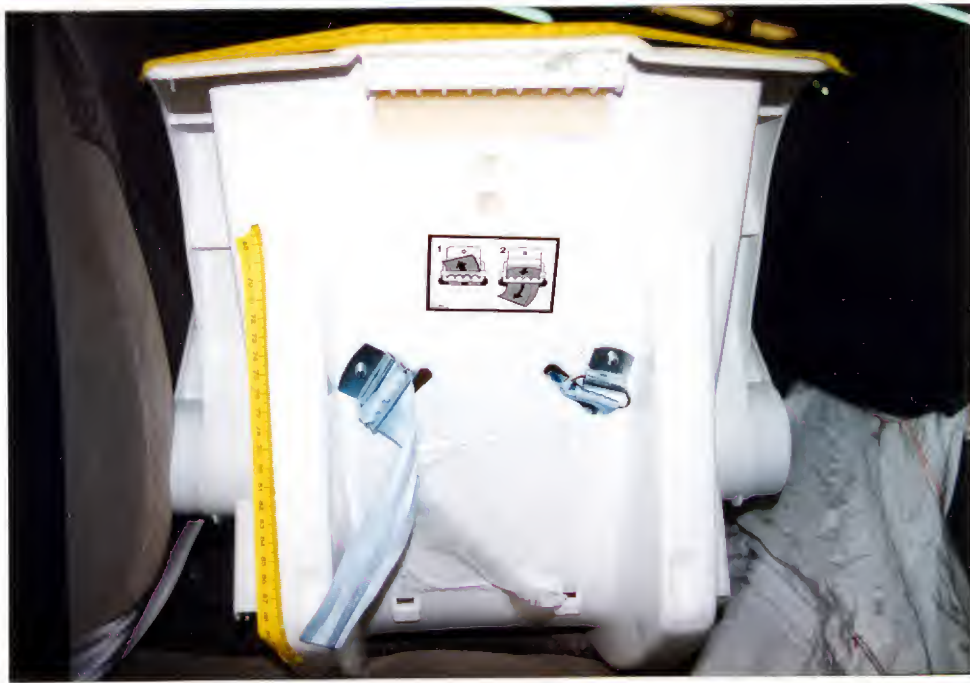
96. View of the back of the infant safety seat with the fabric cover removed showing the fluted area which was consistent with the vertical scuff marks on the lower surface of the air bag module cover.

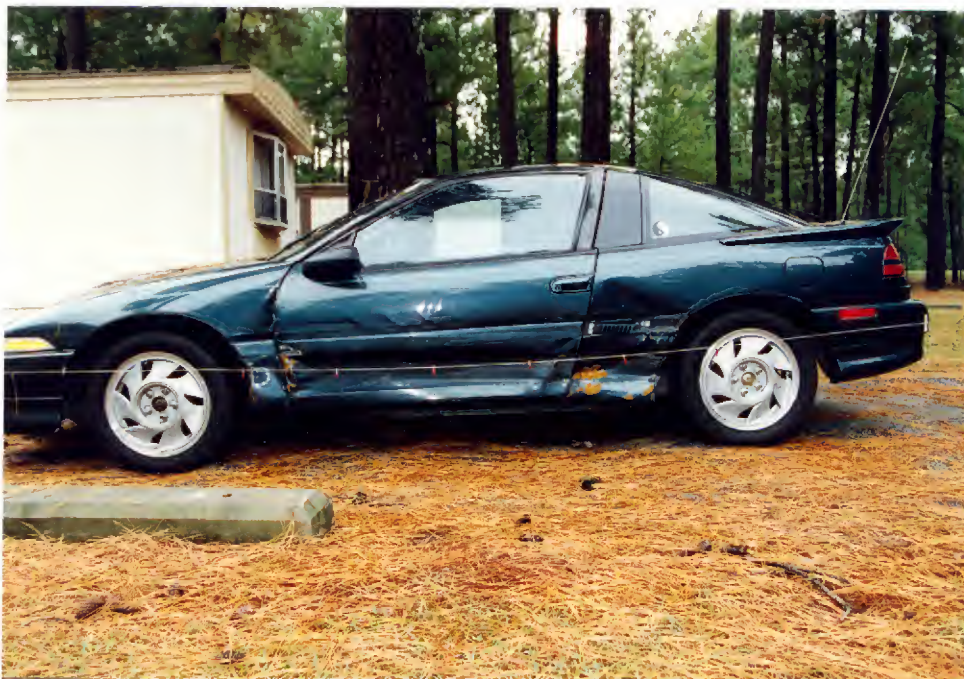
111. View of the left side plane of Vehicle #2.

The 1991 Mitsubishi Eclipse sustained direct contact damage along the left side plane which began 16.5 cm (6.5") forward of the left rear axle and extended forward 213.4 cm (84.0"). Maximum lateral displacement of 11.4 cm (4.5") was located 73.7 cm (29.0") forward of the left rear axle. Crush values below the rub strip are listed below:

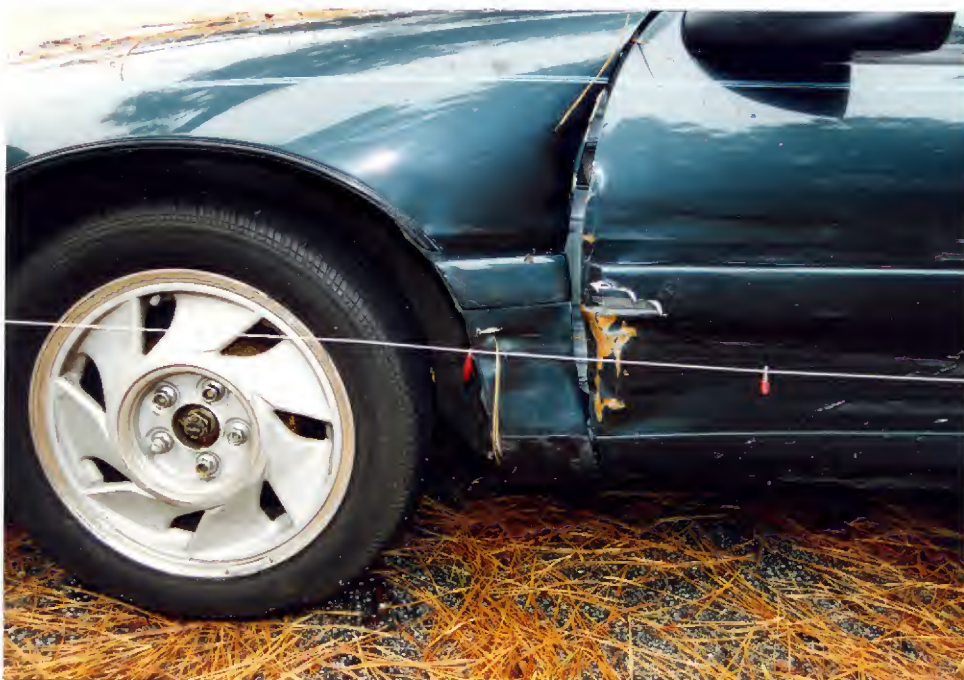
112. View of the contact damage to the left front wheel, left front fender, and left side door.

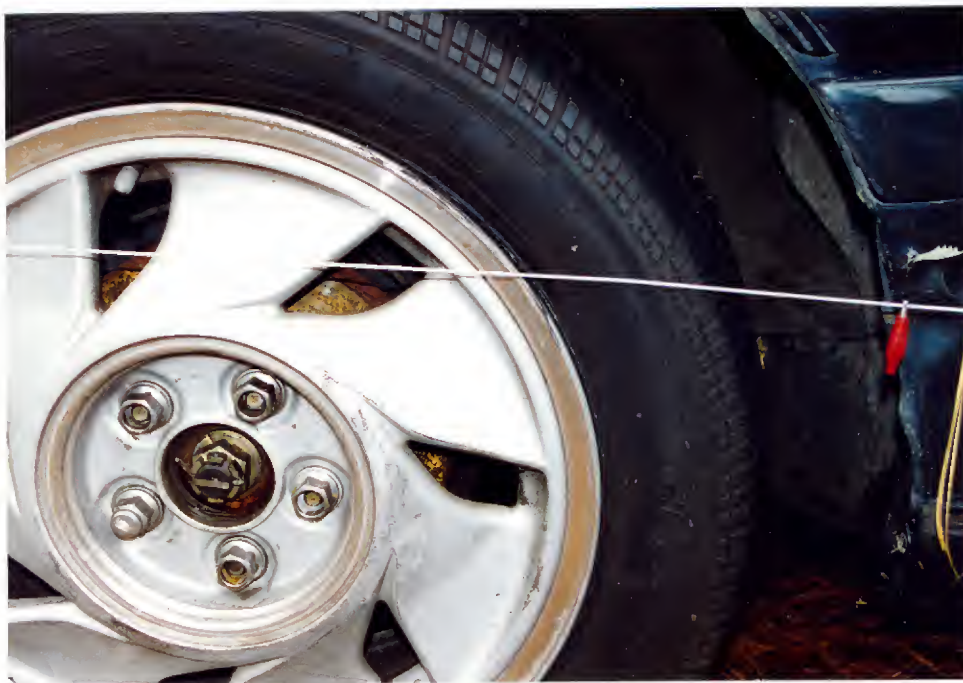
113. Close-up view of the damage to the left front wheel.

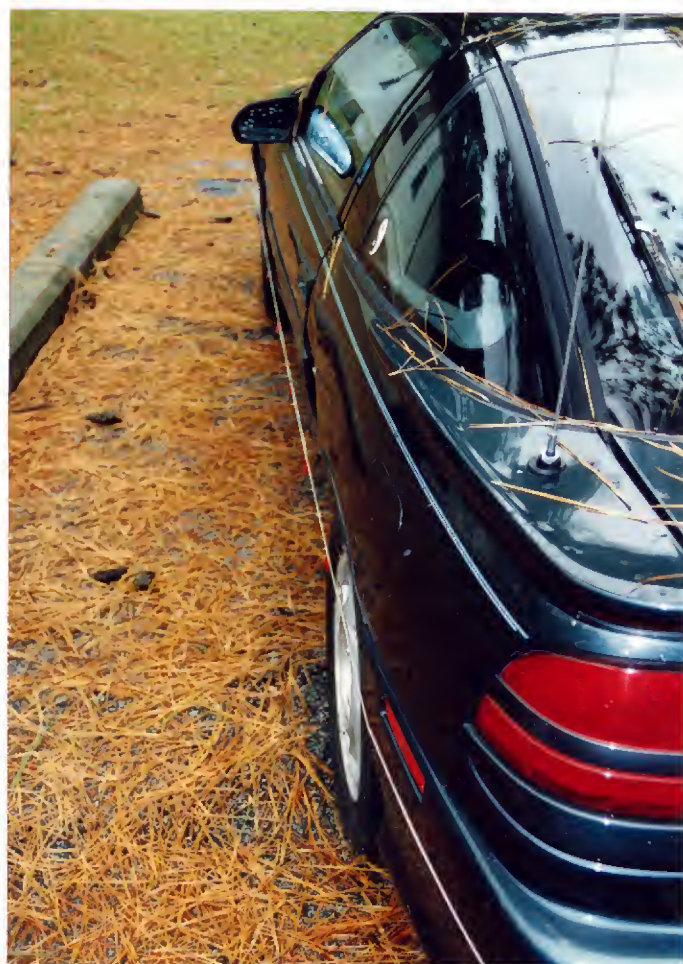
114. Longitudinal view of the left side plane of Vehicle #2 taken from the rear showing lateral displacement.

The exterior damage to Vehicle #2 was located on the left side plane with a maximum lateral displacement of 11.4 cm (4.5") located 73.7 cm (29.0") forward of the left rear axle. The CDC for this impact was 11-LYES-2.

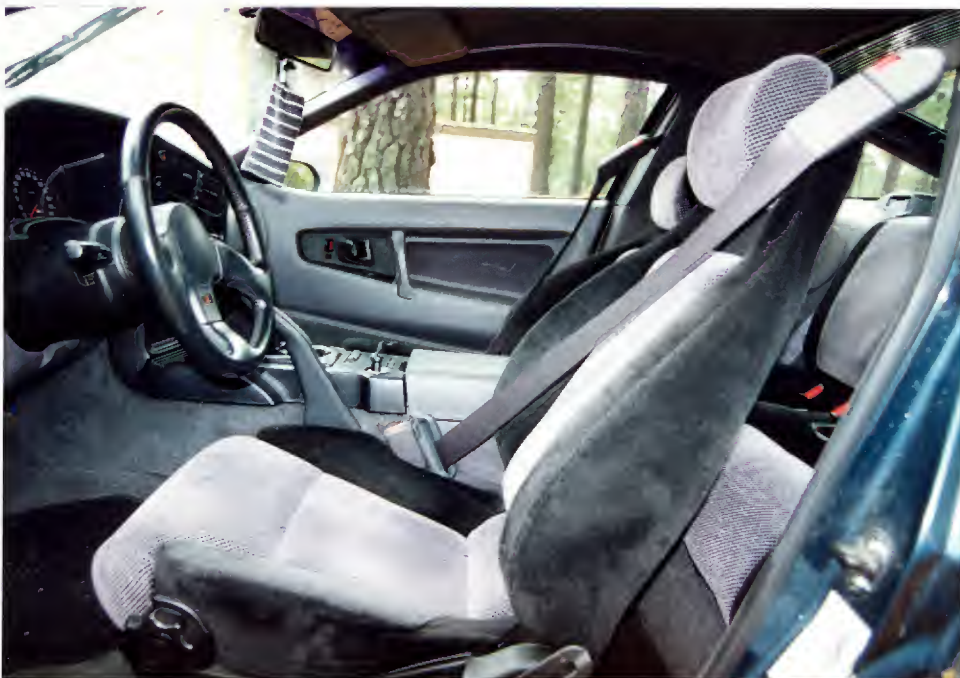
118. Angular view of the front seated area, instrument panel, and windshield of Vehicle #2.

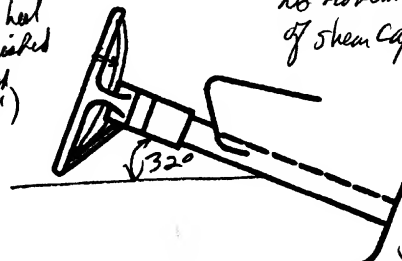
Ergonomic
Sledge mark on
contactSmall spider web on hat
at overlapping (tissue) Sledge mark on hand
(17 1/4")Max. Placable
glass fragments scattered on
top of instrument panel
at 1 piece wedged in panel above
pass air bag flapSee
append
documentation
on notes

There were two small scuffs located on the eyebrow of the driver's side instrument panel in-line with the 9 and 3 o'clock position of the steering wheel rim and the two windshield fractures. A smudge mark was noted on the face of the rear view mirror. There was no damage to the rim of the steering wheel and no movement of the sheer capsules.

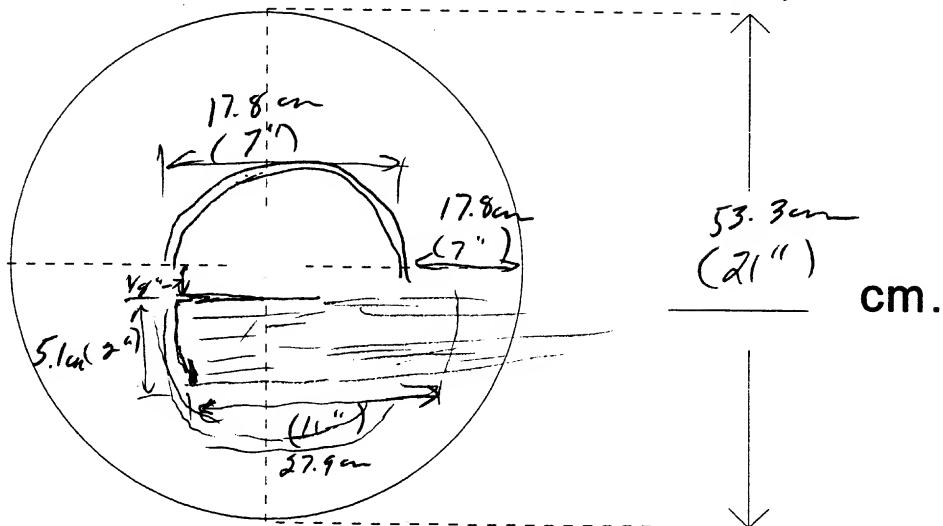
Black
station
transfer
not a defined
① side beg pt

A 3.5 cm (1.4") long scuff mark was noted on the lower surface of the right flap of the driver side air bag module cover. It was located 0.6 cm (0.3") right of the center tear seam and 1.3 cm (0.5") above the bottom seam. This mark was attributed to contact with the driver's right forearm during the SIR actuation cycle.
